# Inspection Report

100 Need an Inspection Dr  
Warwick RI 02893

**House Doctor Home Inspection INC.**

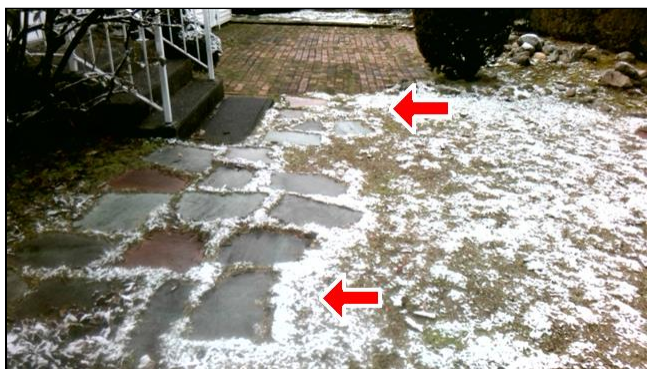
1.0 Item 1 (Picture)

1.0 Patios and walkways are worn.

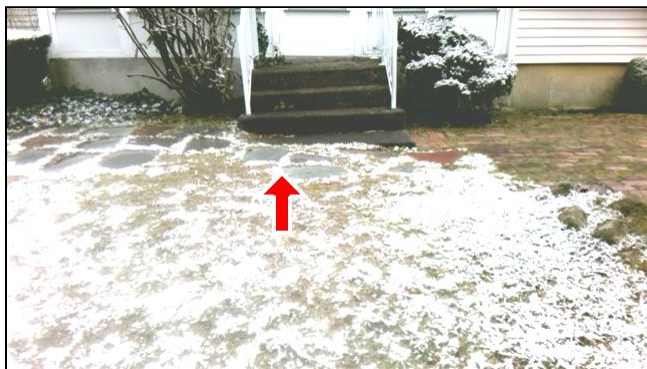
1.1 Item 1 (Picture)

1.1 The Stairs on the rear of house settled. I recommend a qualified licensed contractor evaluate and make needed repairs..

The Stairs on the rear of house settled. I recommend a qualified licensed contractor evaluate and make needed repairs..

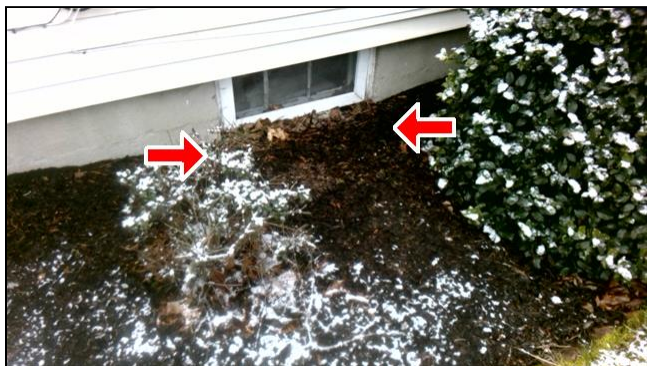
1.6 Item 1 (Picture)

1.6 Basement windows are lower or at soil level height at right side (facing front). Windows wells are needed to prevent water entry and deterioration

Basement windows are lower or at soil level height at right side (facing front). Windows wells are needed to prevent water entry and deterioration

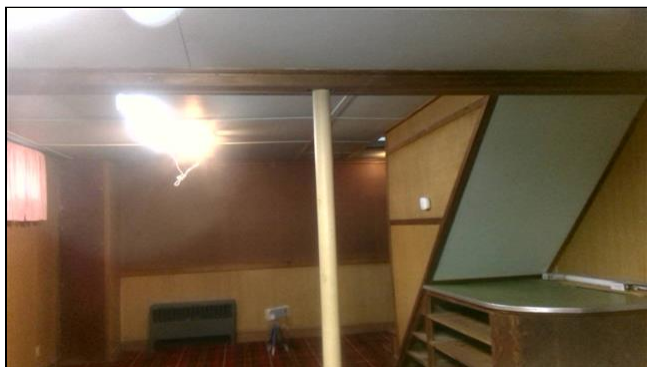
**2.5 Item 1 (Picture)**

**2.5** (2) Half of the walls and ceilings in the finished basement are covered and structural members are not visible. No obvious problems discovered. I could not see behind these coverings.

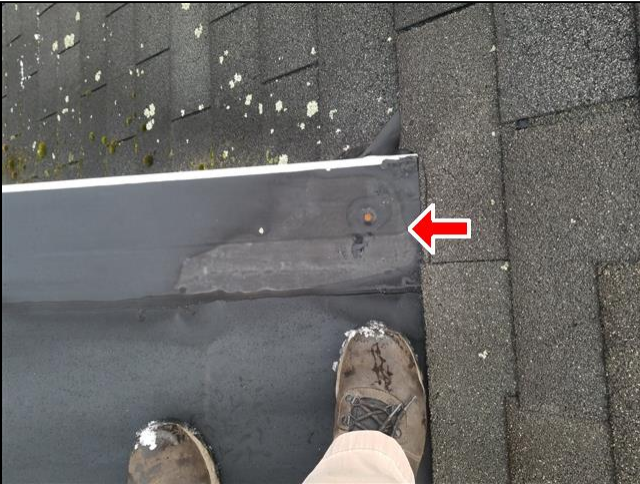
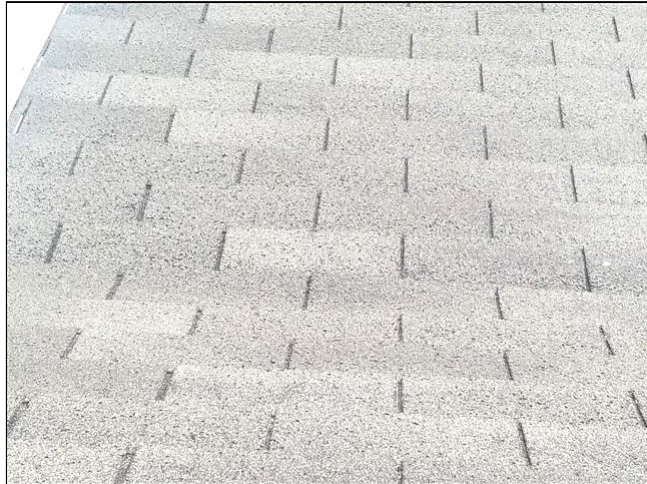
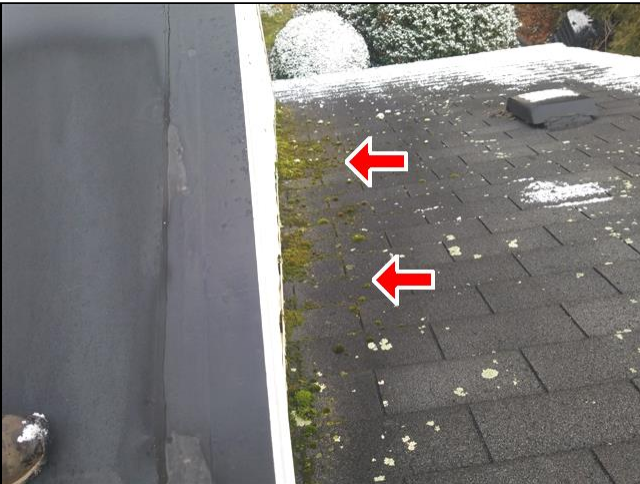
**3.0** The roof covering is old, and near the end of it's life span, signs of weathering, ageing and wear, expect replacement within the next few years or less. One nail in rubber roof, needs attention.

The roof covering is old, and near the end of it's life span, signs of weathering, ageing and wear, expect replacement within the next few years or less. One nail in rubber roof, needs attention.

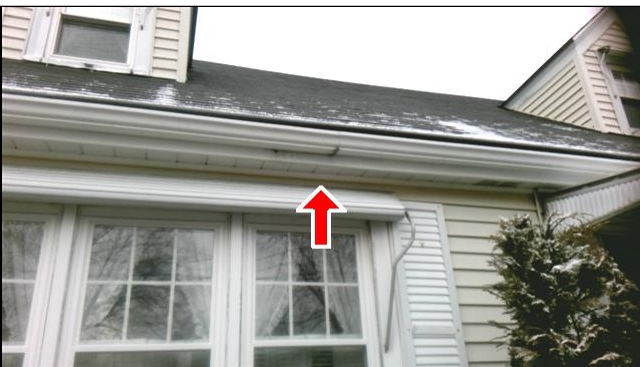
3.4 Item 1 (Picture)

**3.4** The gutter leaks at seam (s) at the front. Repairs needed.

The gutter leaks at seam (s) at the front. Repairs needed.

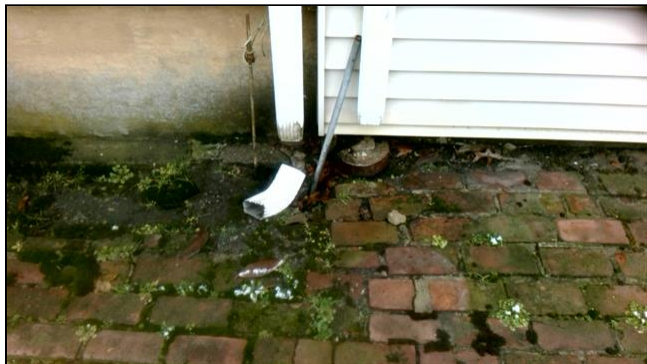
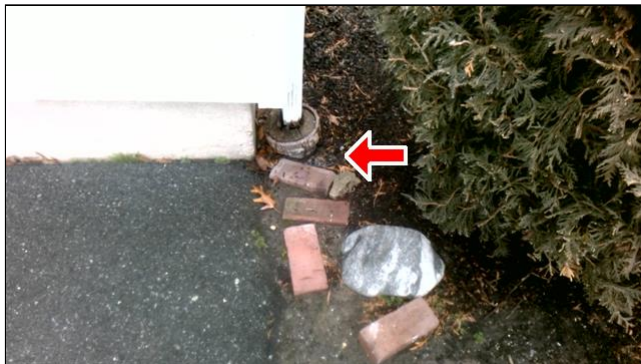
**3.5** Keep or extend downspouts a minimum of 5' away from structure and maintain clear gutters and downspouts for proper drainage away from home. Always trim and maintain vegetation 18" to 24" away from exterior walls. Perform preventive measures for pest and insect control.

There are below ground drain lines for downspouts, I am unable to determine if drains function properly.

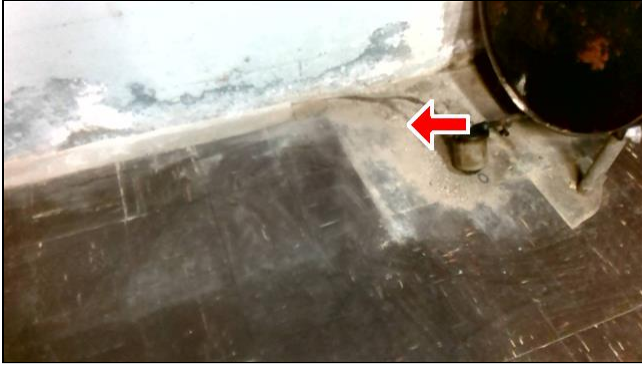
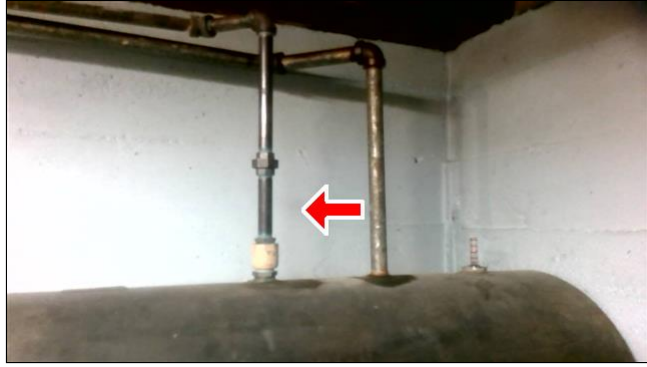
The oil line connection is not protected in the concrete, note: concrete corrodes copper with direct contact. This can contaminate the soil and should be corrected. I did not inspect soil. replacement needed.

The oil line connection is not protected in the concrete, note: concrete corrodes copper with direct contact. This can contaminate the soil and should be corrected. I did not inspect soil. replacement needed.

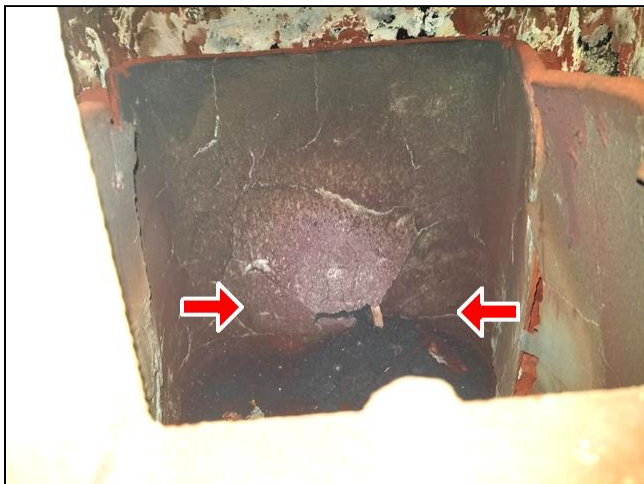
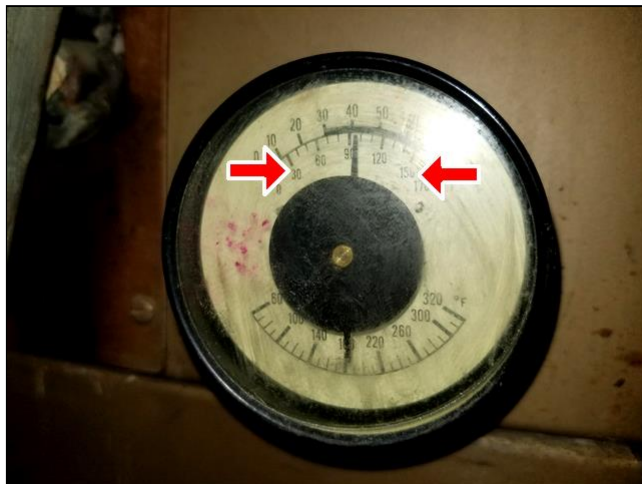
**5.0** The oil-fired boiler was operating on, or reading high pressure and has a deteriorated fire box. Refer to a licensed HVAC contractor for evaluation and repairs.

The oil-fired boiler was operating on, or reading high pressure and has a deteriorated fire box. Refer to a licensed HVAC contractor for evaluation and repairs.

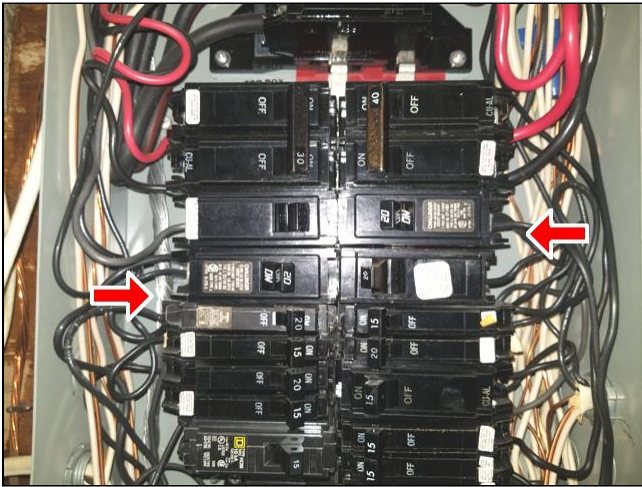
6.3 Item 1 (Picture)

**6.3** The main panel in the basement needs repair, there was doubled wiring on two circuits, evaluation and repair needed by a licensed electrician.

The main panel in the basement needs repair, there was doubled wiring on two circuits, evaluation and repair needed by a licensed electrician.

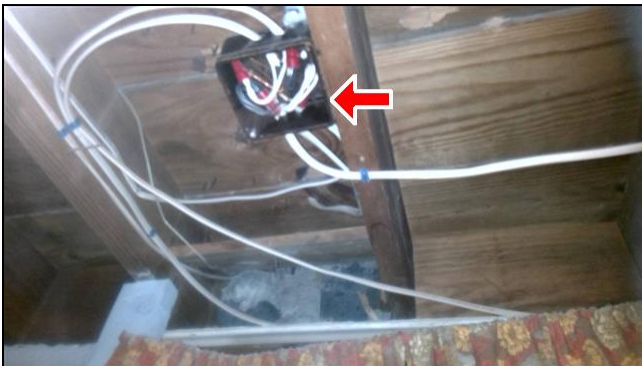
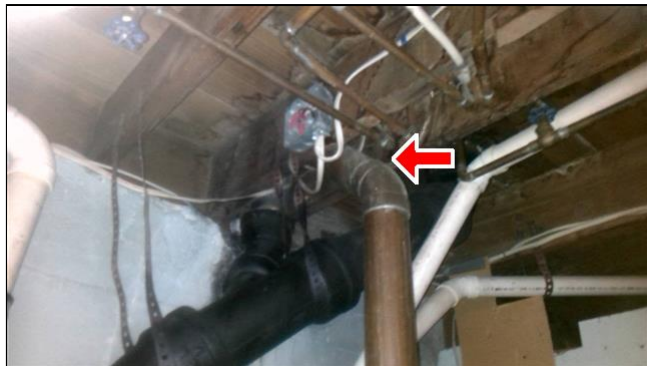
**6.4 (1)** Two or more junction boxes need coverplates basement. Refer to an electrician for repair.

(1) Two or more junction boxes need coverplates basement. Refer to an electrician for repair.

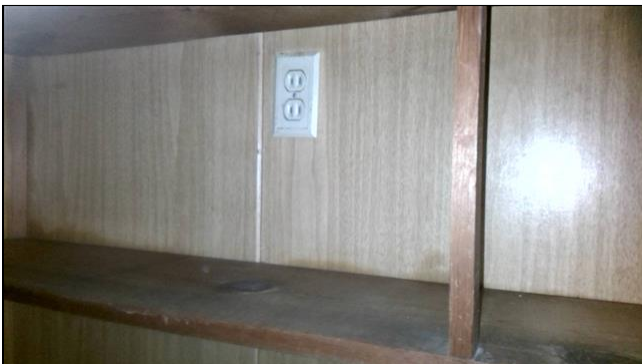
6.4 Item 3 (Picture)

**6.4 (2)** This home contains two prong electrical outlets, this is normal for this era home, GFCI upgrades recommended, this is only for your information.

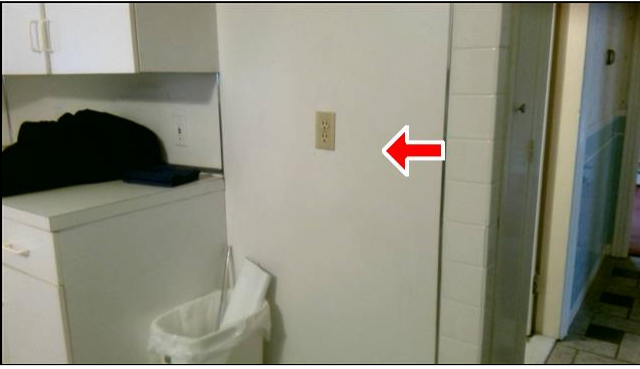
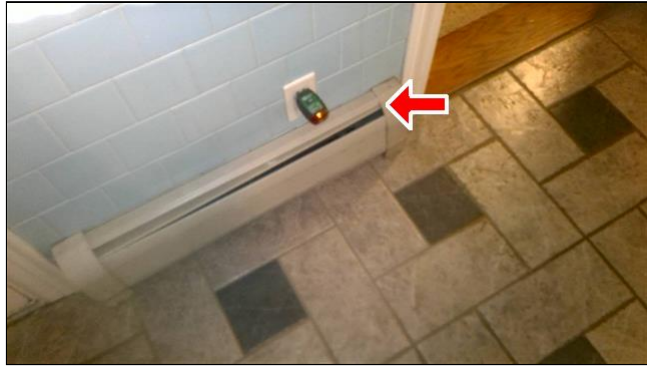
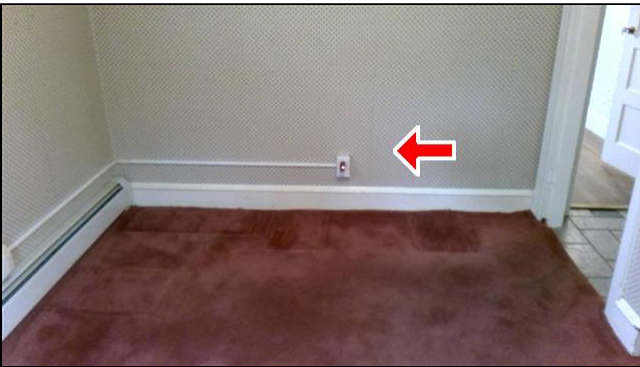
**6.4 (3)** Some "Three-prong" outlet(s) are not grounded, GFCI protection is recommended at kitchen and Bedroom(s). Refer to a licensed electrician for repair.

(3) Some "Three-prong" outlet(s) are not grounded, GFCI protection is recommended at kitchen and Bedroom(s). Refer to a licensed electrician for repair.

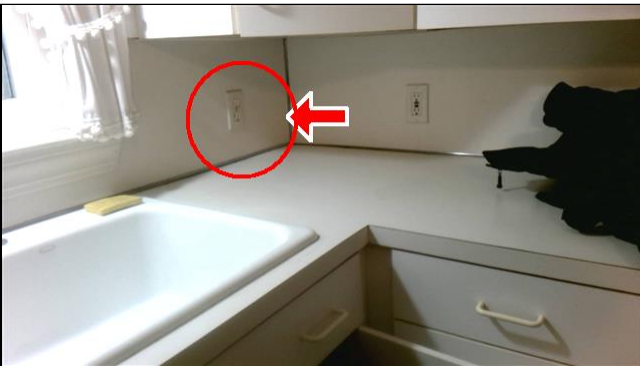
6.4 Item 7 (Picture)

**6.4 (4)** One Outlet is not gfci protected at kitchen. Refer to a licensed electrician for repair.

(4) One Outlet is not gfci protected at kitchen. Refer to a licensed electrician for repair.

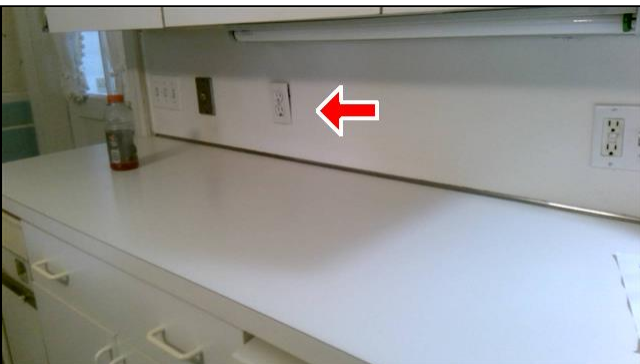
6.4 Item 8 (Picture)

**6.4 (5)** One Outlet is loose in wall at kitchen left of sink. Refer to a licensed electrician for repair.

(5) One Outlet is loose in wall at kitchen left of sink. Refer to a licensed electrician for repair.

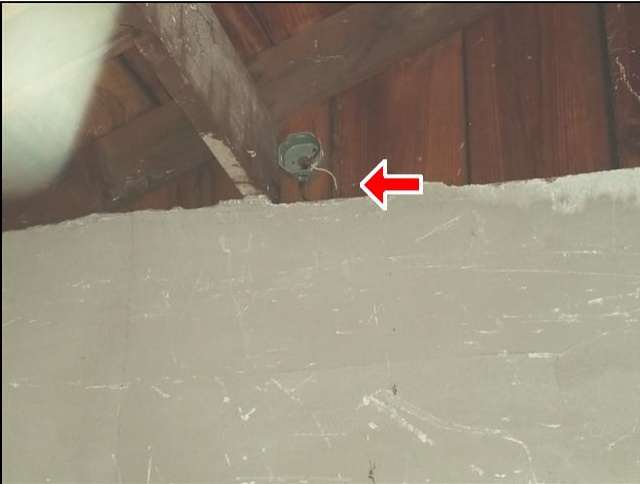
6.4 Item 9 (Picture)

**6.4** (6) One junction box with exposed wire(s) needs placing inside a box with a cover-plate garage. Refer to an electrician for repair.

(6) One junction box with exposed wire(s) needs placing inside a box with a cover-plate garage. Refer to an electrician for repair.

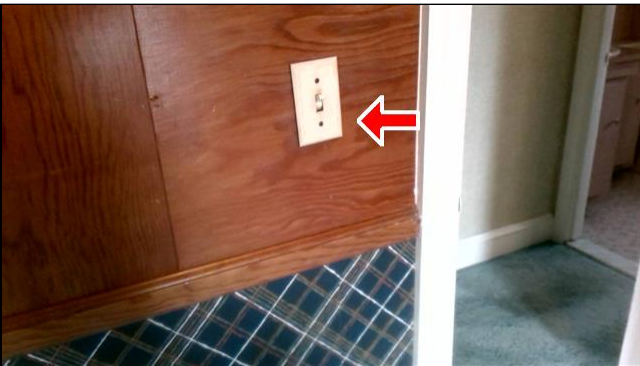
6.4 Item 10 (Picture)

**6.4** (7) The wall switch(s) are old or weak "lever" (recommend replacing) at multiple rooms. Refer to an electrician for repair.

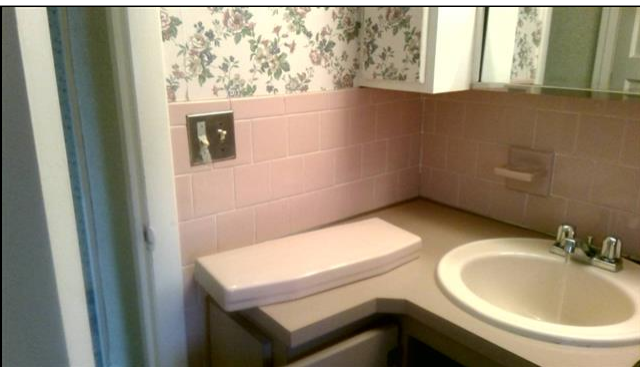
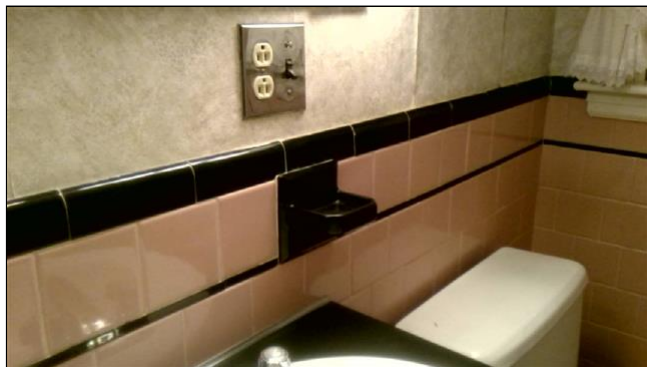
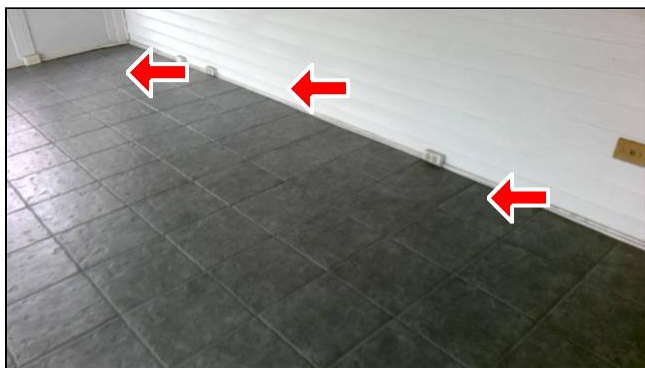
**6.6** GFCI outlet upgrades are recommended at bathroom, garage and exterior porch, this is an upgrade recommendation and not required but would improve the safety of this circuit.

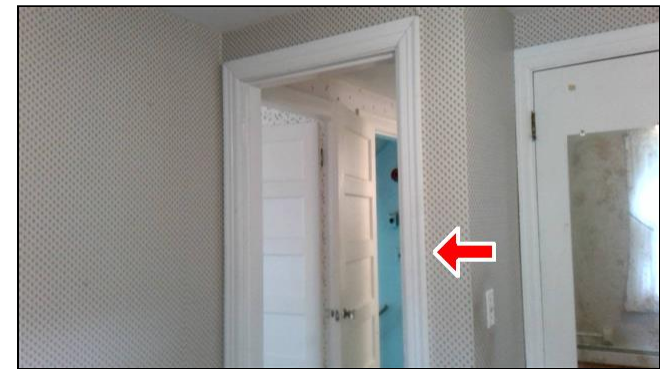
7.0 Item 1 (Picture)

7.0 The interior door is missing at main level Bedroom. A qualified person should repair or replace as needed.

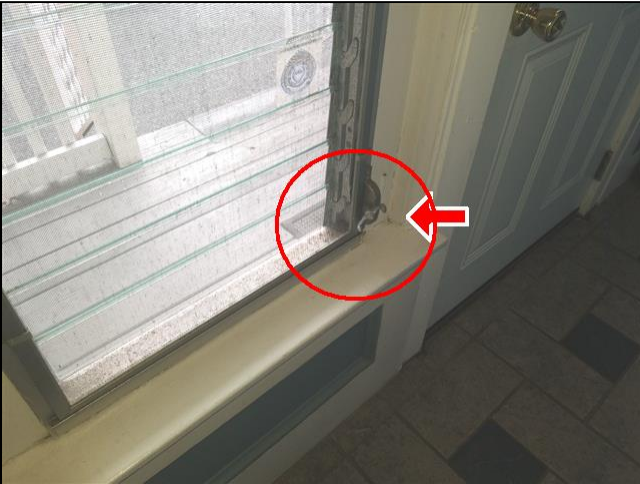
7.1 Item 1 (Picture)

7.1 (1) Three windows have stripped crank handles at the rear Sunroom and front door hallway. A qualified person or licensed contractor is recommended for repairs.

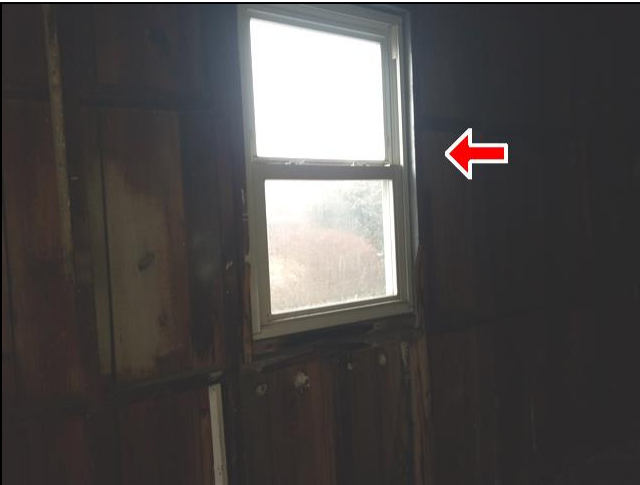
7.1 Item 2 (Picture)

7.1 (2) One window has broken lost seal(s) at the garage. A qualified person or licensed contractor is recommended for repairs.

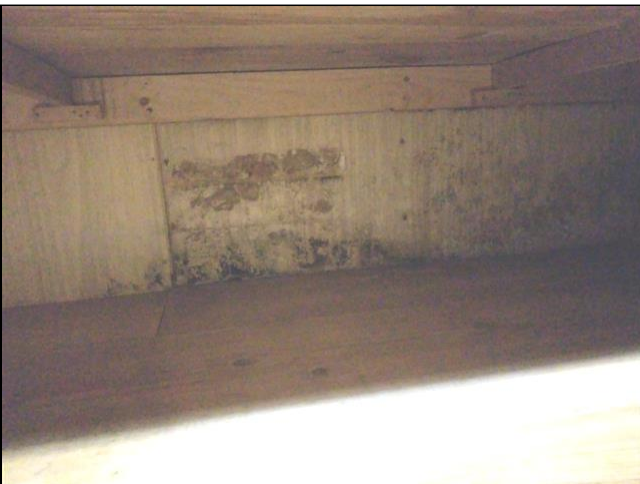
7.2 Item 1 (Picture)

7.2 (1) Small amount of visible fungi in basement cabinet(s), spot cleaning recommended and climate control (dehumidifier).

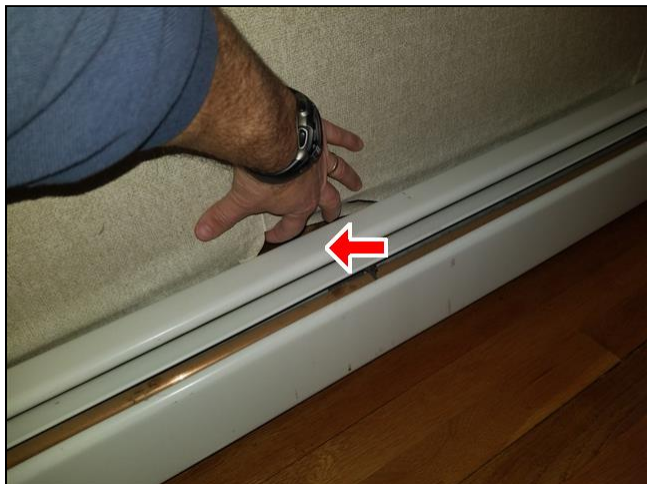
7.2 Item 2 (Picture)

7.2 (2) Notice: the sheet rock does not extend all the way down behind the baseboard heat in areas on exterior wall, this is considered a cosmetic repair for your information.

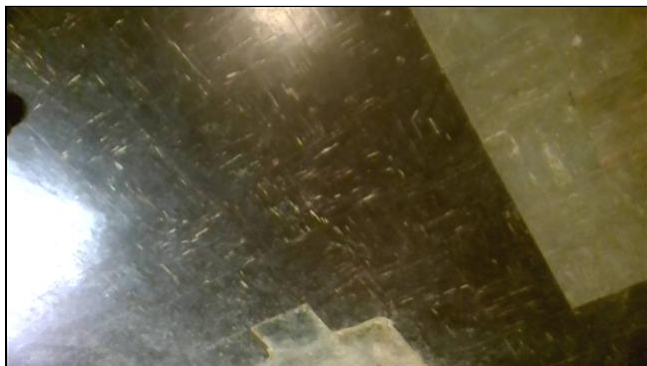
7.3 Item 1 (Picture)

7.3 (2) Notice: this home contains 9x9 tiles, many older tiles may contain asbestos, sampling would be needed to verify.

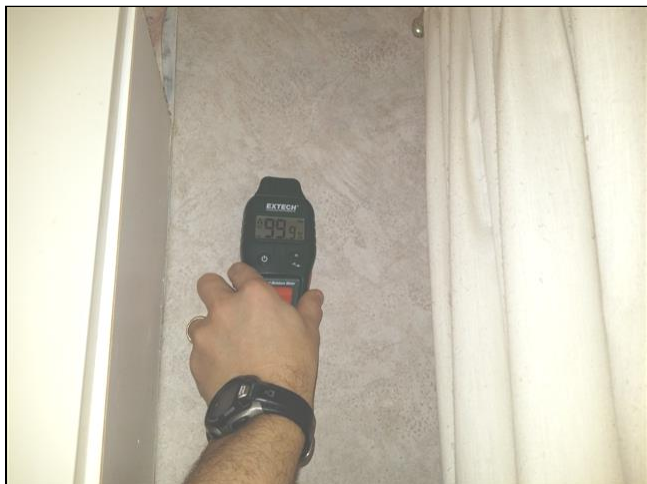
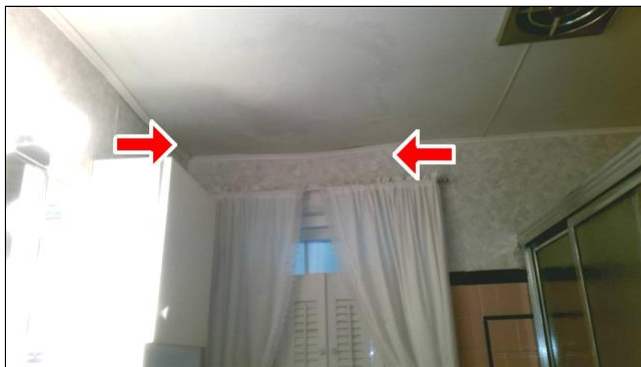
7.4 The ceiling and wall reveals water stains that tested wet with use of a moisture meter indicating an active leak at the lower bathroom from the upper bathroom. refer to a plumber for further evaluation..

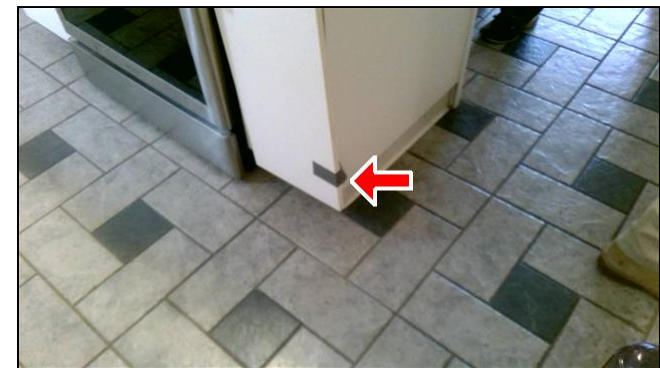
8.2 Item 1 (Picture)

8.2 Cabinet door is damaged at island. This is a cosmetic issue for your information. Recommend repair or replace as necessary.

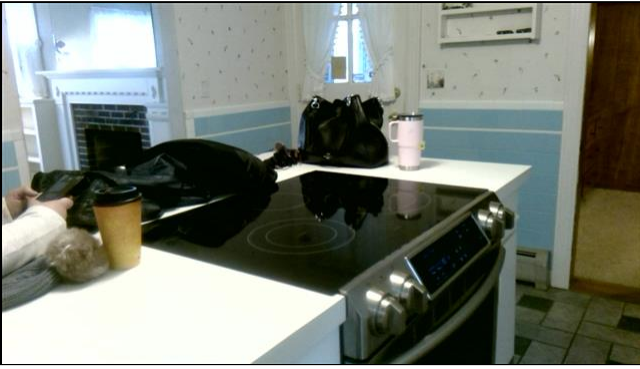
8.3 Item 1 (Picture)

**8.3** There is no exhaust fan installed for the range/ cooktop, exhaust fan needed to remove cooking smoke from home, repair by a qualified person advised.

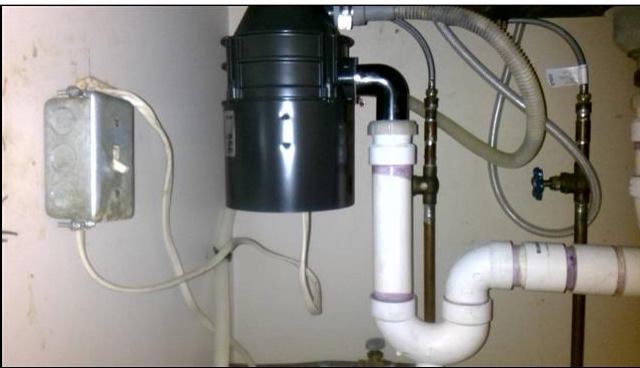
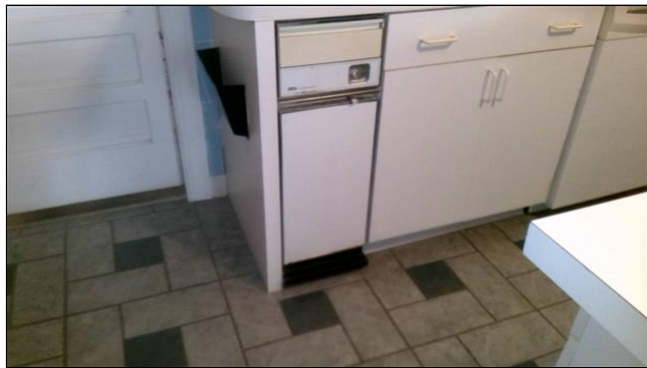
**8.7** The food disposer and trash compactor would not operate or non functional. I recommend repair as needed.

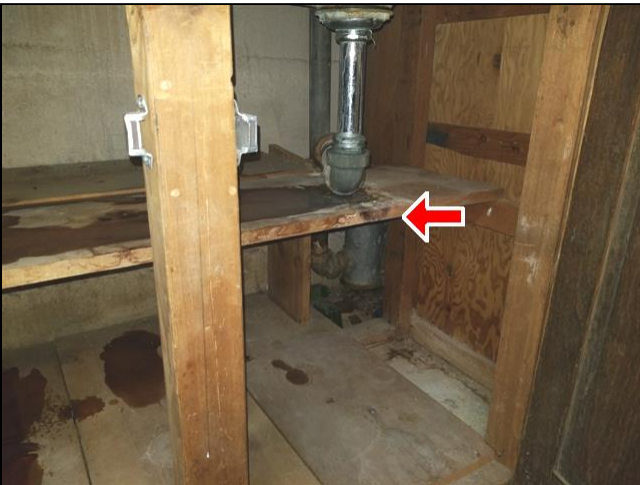
8.8 Item 1 (Picture)

**8.8** The waste line at clothes washer sink is corroded and is leaking. I recommend repair or replace as needed.

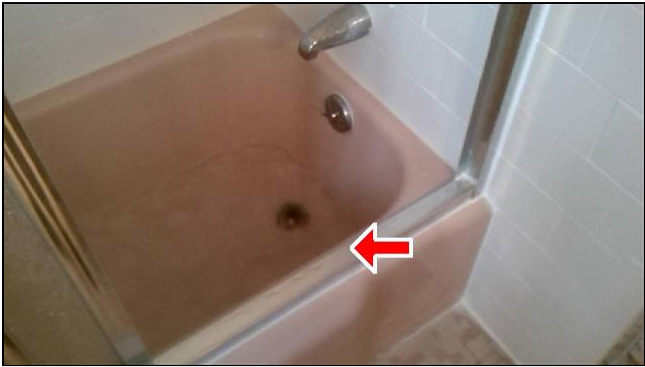
9.1 Item 1 (Picture)

9.1 The waste line drains slowly at the 2nd level bath. A licensed plumber should evaluate and make needed repairs.

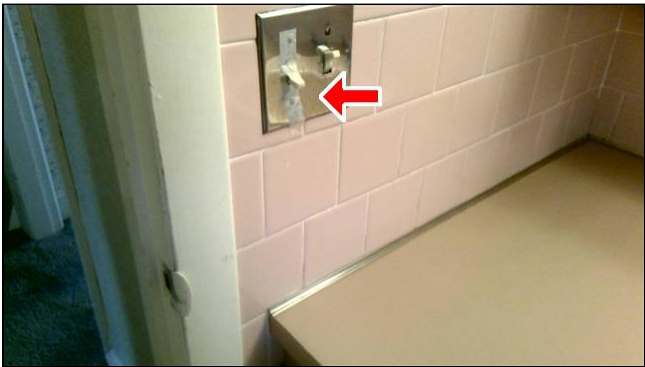
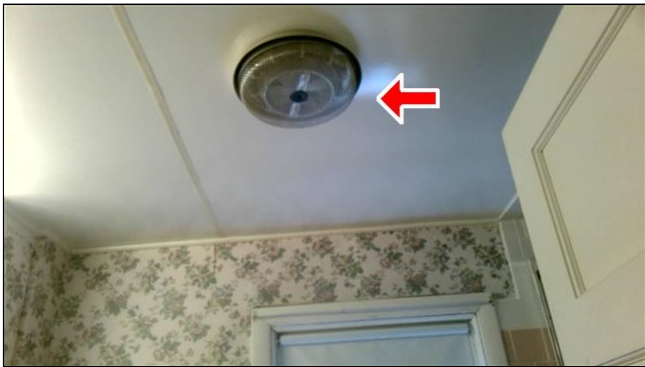
9.3 The Exhaust fan switched is tapped off at the 2nd level bath. A qualified person should repair or replace as needed..

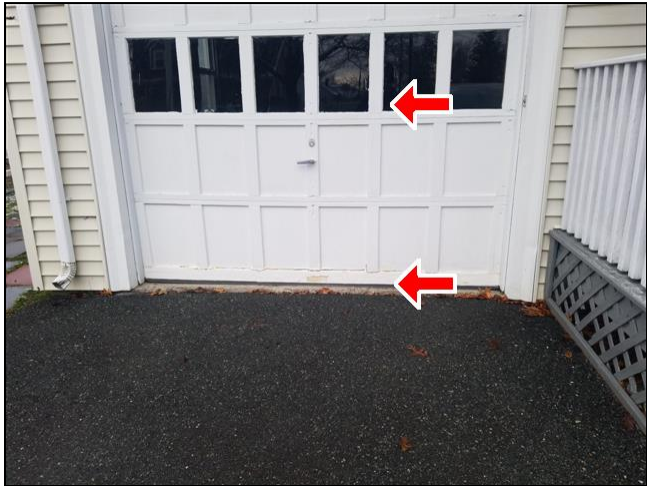
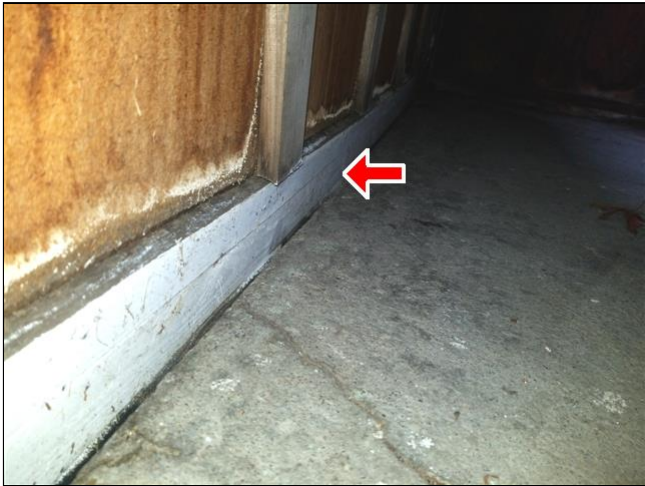
**10.3** The garage door at the front of home is deteriorated and damaged with has broken glass(note: did not test door opener). A qualified person should repair or replace.
